Superior Coal Mines,  
Wooden Structure  
Sections 28, 29, T21N, R102W  
Horse Thief Canyon  
Old Superior Mines and Townsite  
about 1/4 mile north of South Superior  
Sweetwater County *South Superior vicinity*  
Wyoming

HAER No. WY-51-C

Superior Coal Mines, Wood Structure  
HAER No. WY-51-C

Wood Structure: Site 48SW4068, Structure C (SE/NW/SW/SE Section 20, T21N, R102W 12/667800E/4626420N)

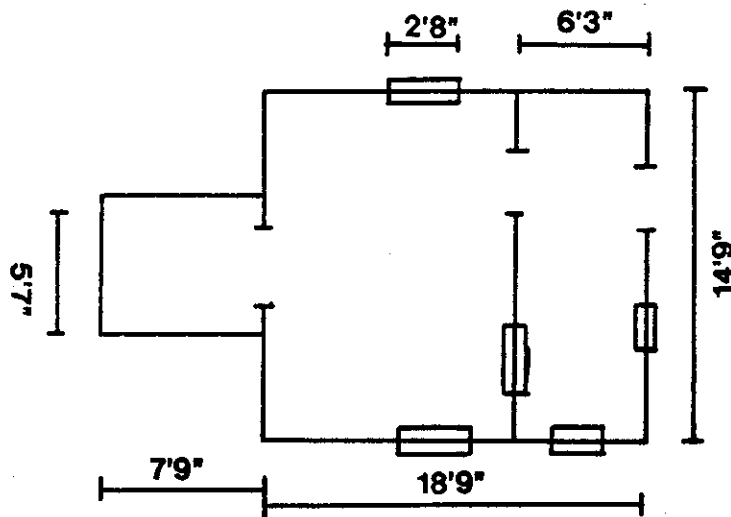
Wooden Structure  
Superior Coal Mines  
HAER No. WY-51-C  
(Page 3)

The wood structure (Structure C) is rectangular in shape with the long axis oriented from east to west. The overall dimensions of the structure are 26 feet 8 inches east to west by 14 feet 9 inches north to south. The structure has a flat roof which slopes downward to the west. The roof is covered with green asphalt tar paper. The foundation of the building consists of 8 inch x 8 inch milled lumber beams resting on uncut dry laid sandstone slabs. The walls consist of milled lumber planks secured to a frame of 2 inch x 4 inch boards with metal nails.

The interior of Structure C is divided into three rooms, an eastern room or porch, a large central room, and a small west room excavated back into the hillside. The east room is rectangular with the long axis running north to south. Its overall dimensions are 14 feet 3 inches by 6 feet 0 inches. The height from the floor to the roof is 6 feet 9 inches. The floor of the room consists of milled lumber boards. The walls consist of the wood frame and exterior wood planking of which much of the eastern wall has been removed. The western wall serves to separate the east room from the center room. This dividing wall has two openings. A doorway which provides access from the east room to the center room is located near the north edge of the wall. The door has been removed. A second opening is located near the south edge of the dividing wall. The window has had its glass and frames removed.

The center room is rectangular in shape with the axis running from north to south. The dimensions are 13 feet 10 inches by 11 feet 7 inches. The height of the room ranges from 8 feet 6 inches at its east end to 5 feet 7 inches at the west end. The floor consists of milled lumber boards. The walls consist of the wooden frame and exterior boards and the roof consists of the wooden 2 inch x 4 inch board rafters. The northwest corner of the structure contains a small fireplace. The fireplace consists of a stack of concrete blocks with a small hole in the south side of the lowest two blocks. A vertical shaft runs up through the center of the stack of blocks which extends through the roof forming a chimney. The entire stack of cement blocks is supported by four 2 inch x 2 inch wooden legs which hold the blocks 4 feet 5 inches off the floor.

The third room in Structure C has been excavated into the hillside west of the structure. Access to this room is through a doorway in the center of the west wall. The door has been removed. The room had a roof which was an extension of the roof of the main structure, however, the roof collapsed and has been partially removed. This has allowed sediments to partially fill the room and cover the floor. The walls of the west room consist of dry laid uncut sandstone slabs chinked with mud.

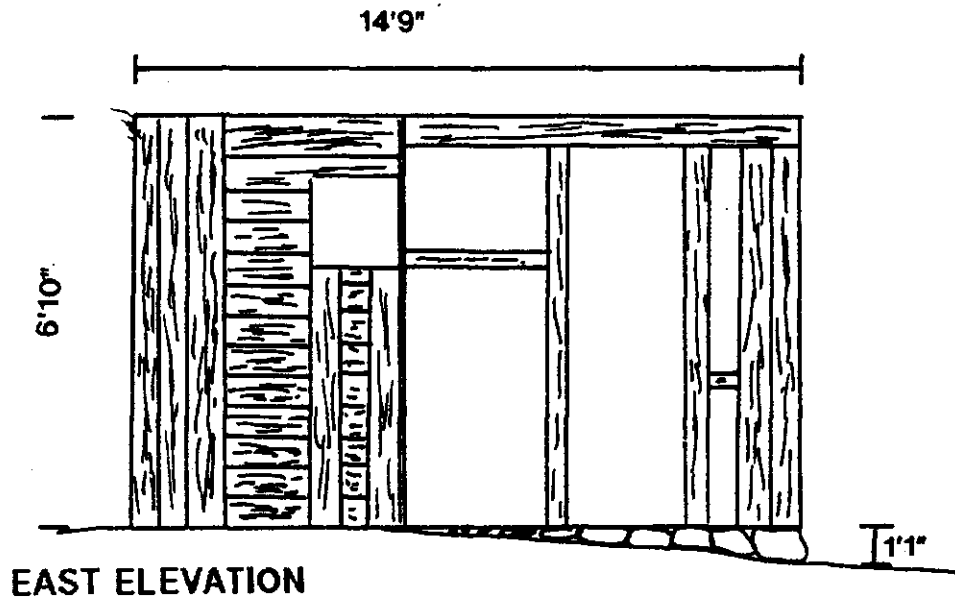
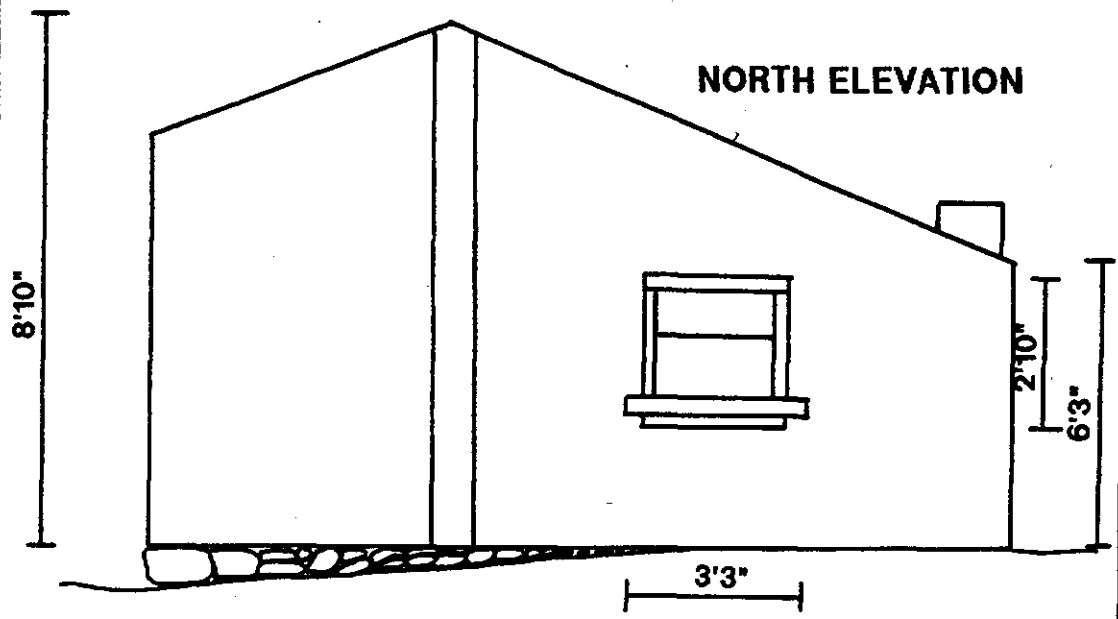
Wood Structure  
Superior Coal Mines  
HAER No. WY-51-C  
(Page 4)

The locality consists of a wood frame (Structure C) structure with an associated dugout, automobile garage (Structure D). The structure is located along the east slope of a south to north trending finger ridge which extends into the valley of Horse Thief Draw approximately 1 mile northwest of Superior. The dugout garage is located directly north of the wood structure.

Access to Structure C is through a doorway near the north end of the east elevation. The doorway has been removed. A second opening was also noted in the east elevation. This opening was a window. The window has had all glass as well as the wooden surrounds removed. Two openings were noted in the south elevation. Both were windows. The first of these is located at the east end of the south elevation. The glass and wood surrounds have been removed. The second window is located near the center of the west elevation. The window is a two over double hung window with wooden frame and plain surrounds. The glass has been removed. One opening was noted in the north elevation. This opening is a window which is also a two over double hung window with wooden frames and plain surrounds. It, too, is missing its glass.
